REPORT NO. NADC-87014-60

A STUDY OF ZN/SN EMI-SEAL MATERIAL

FINAL REPORT

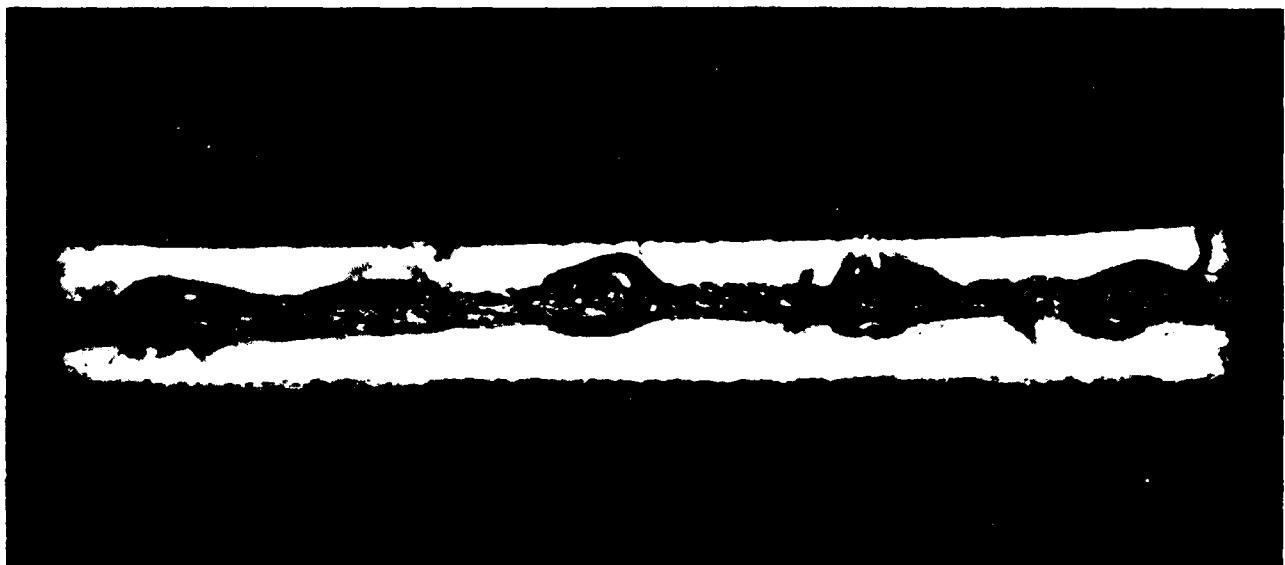
Figure 1 - Schematic of the F/A-18 EMI-seal and a photograph of the specimen used.

F/A-18 EMI SEAL

SCHEMATIC DIAGRAM OF SEAL

UNEXPOSED SPECIMEN

A shipboard exposure test of the 20% Zn/Sn arc-sprayed coating was performed by exposing a number of specimens to the carrier environment on the USS CONSTELLATION for six months. Salt spray (5% NaCl/SO₂) tests were performed on both the Zn/Sn/Monel and Zn/Sn/Ferrex braid EMI seal assemblies, as shown in Figure 1. Also tested were 7149 Al panels with a 20% Zn/Sn coating pretreated with (1) a glass bead blast, (2) a coating of MIL-C-81309, (3) a combination of (1) and (2) and (4) no pretreatment. A chemical analysis of the corrosion product, removed from the seal assemblies, was made after a five-day exposure to SO₂/salt spray. The electrochemical tests consisted of the corrosion potential, galvanic corrosion current and potentiodynamic polarization measurements. All electrochemical tests were performed in a 3.5% NaCl (pH2) solution. No special surface cleaning treatments were applied to the coating before testing.

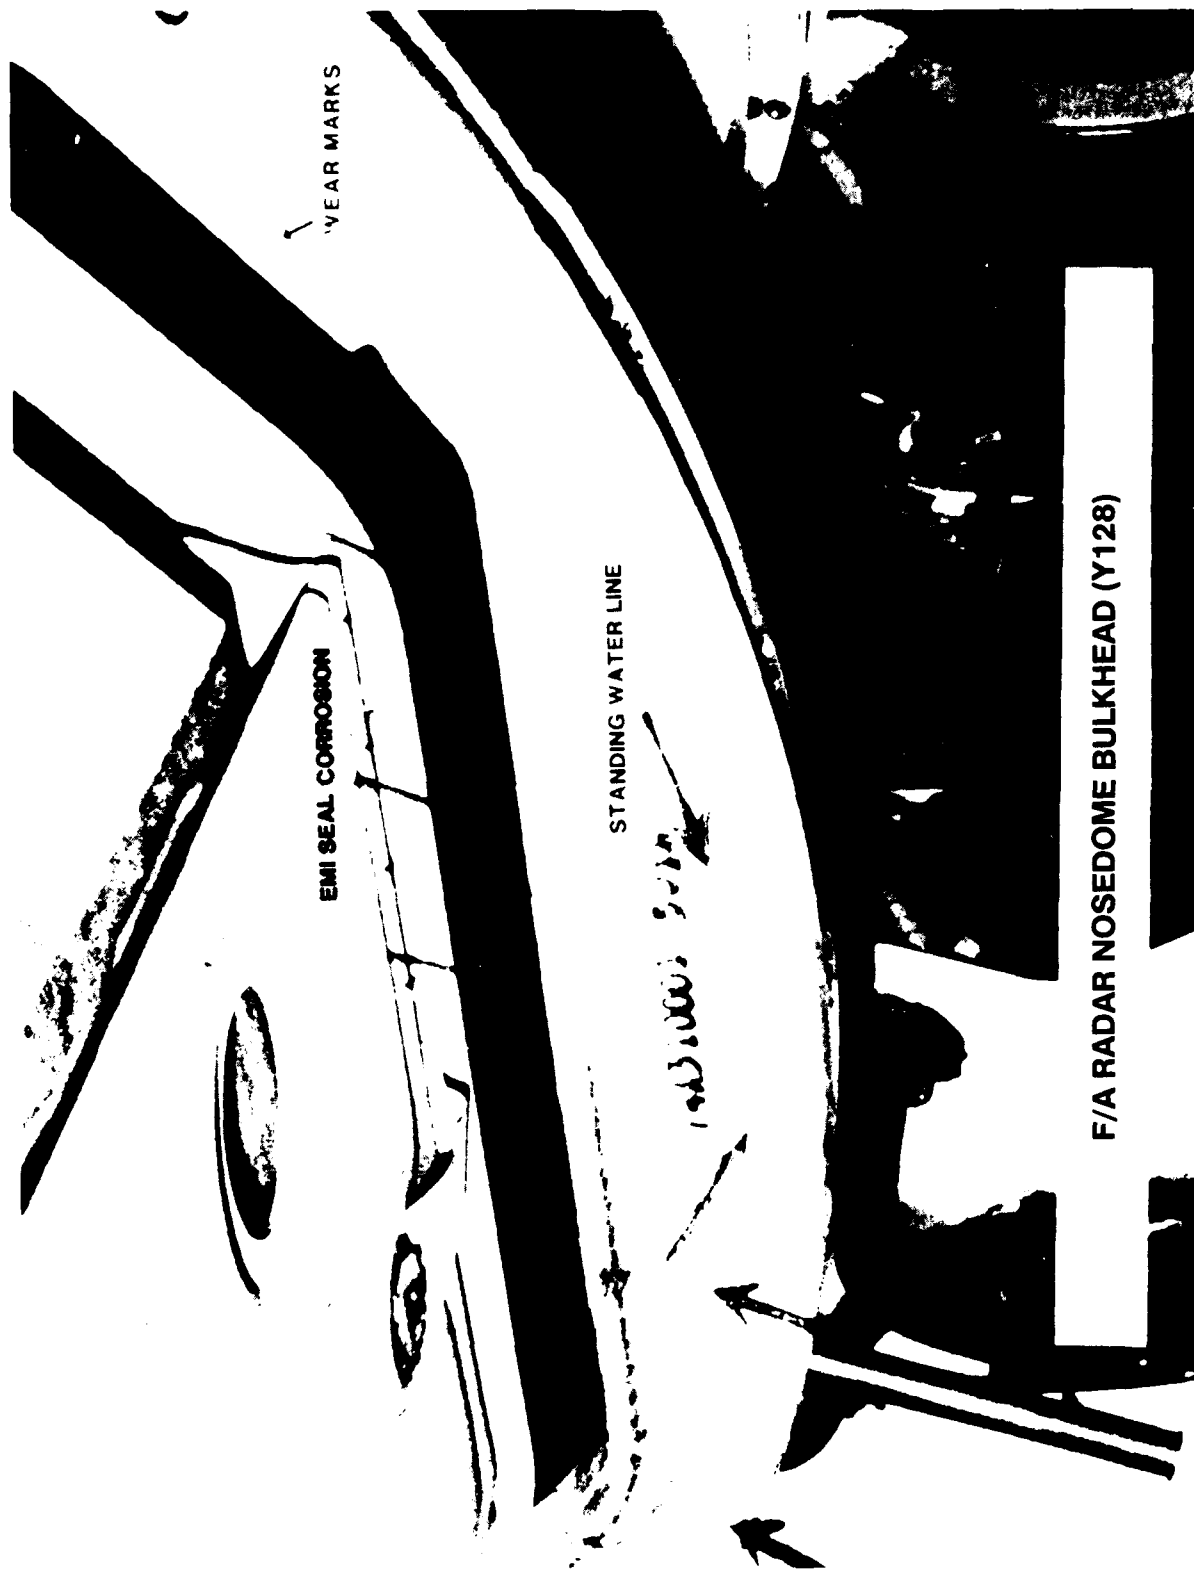
Figure 2 - Corrosion under the EMI-seal area in the F/A-18 Radar Nosedome Bulkhead (Y128).

Electromagnetic interference (EMI) seals are required for the Navy's F/A-18 aircraft because of the high electromagnetic environment present on aircraft carriers. These seals prevent the reception as well as broadcast of the electromagnetic energy. They are vital for the proper functioning of avionics and for lightning strike protection. Poor designs and galvanic incompatibility of earlier seals, such as silver-filled epoxy (adhesive material) and Ferrex braid system with aluminum alloy structural materials, have been the major reasons for excessive corrosion damages. Due to the severity of the carrier environment, the corrosion damages have been reported to be beyond the means of simple corrective maintenance efforts. During an Age Exploration Program Depot (AEPD) inspection in 1984, extensive corrosion and pitting, pits up to 70 mils deep (the maximum correctable depth is 10 mils), were found in the aluminum alloy structural materials. A quick solution was instituted to replace the silver-filled epoxy in the EMI seal with a 20% Zn/Sn arc-spray coating. Schematic diagrams of both the old and new seal designs and an unexposed Zn/Sn/Ferrex seal are shown in Figure 1. The 20% Zn/Sn coating was designed to protect the structural aluminum alloy cathodically. However, after three to six months of carrier exposure, structural corrosion damages associated with the new EMI seal were reported (1,2). Figure 2 shows an example of corrosion under the EMI seal and water intrusion on the F/A-18 Radar Nosedome Bulkhead (part number Y128). Additionally, the combination of corrosion and aircraft vibrations caused corrosive wear (dark areas in Figure 2) of the Zn/Sn coating. The formation of corrosion products may also reduce the effectiveness of the EMI seal since most oxides are insulators and create a non-conductive path. Thus, a study of the 20% Zn/Sn coating material was made and its corrosion behavior with respect to the substrate metal (i.e. Al alloy) was evaluated. Recently, a corrosion inspection of F/A-18 aircraft (AEPD, Dec 1985) was performed after one carrier deployment (3). It was reported that the Dorsal Longerons/EMI installation of the F/A-18 revealed large accumulation of powdery residue, a corrosion product. Corrosion pits were noted in the areas that were covered by the metal spray coating. The deepest pits measured were about 0.020 to 0.035 inches. The inspection report concluded that, one year after the application of the Zn/Sn coating and one carrier deployment, the new EMI installation did not perform as well as expected.

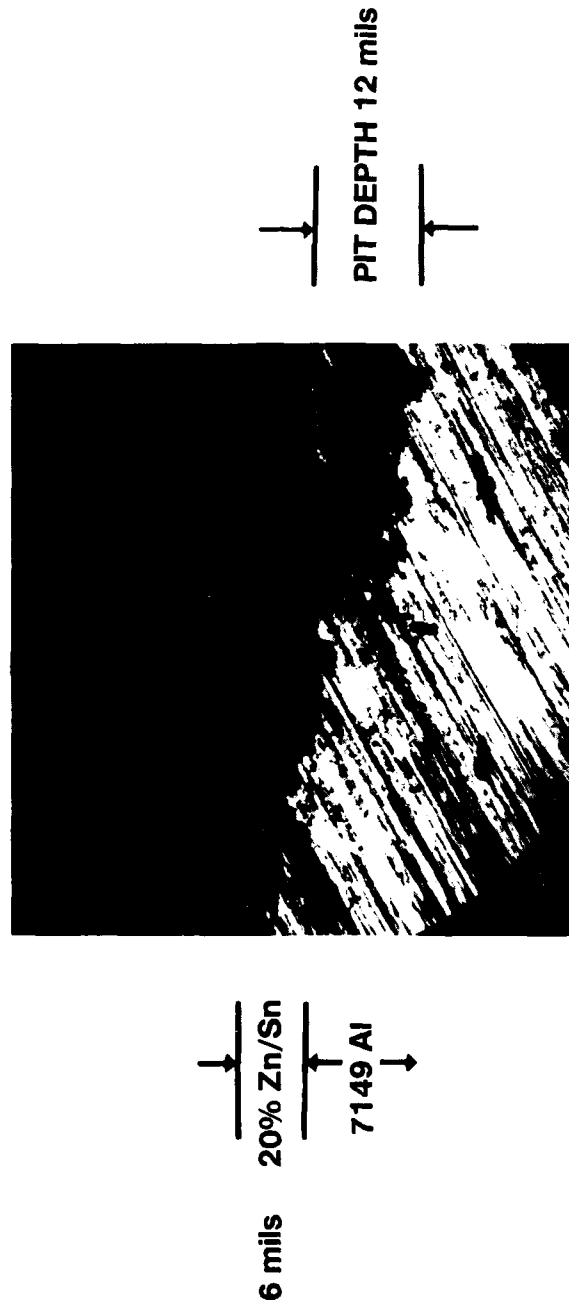
The 20% Zn/Sn arc-sprayed coating on the 7149-T7 Al alloy showed severe pitting and general corrosion of the substrate after a six-month exposure on the carrier, USS CONSTELLATION. Both the unexposed test specimens from the carrier were as shown in Figure 6. During the carrier's deployment in the Indian Ocean, pitting corrosion had penetrated through the coating and into the substrate. A cross section of an exposed carrier specimen, in Figure 7, shows pits in the aluminum substrate up to 12 mils deep and, the area of the panel where the Zn/Sn coating was removed.

EXPOSED 6 MONTHS TO CARRIER ENVIRONMENT

Figure 7 - Cross-section view of Figure 6.

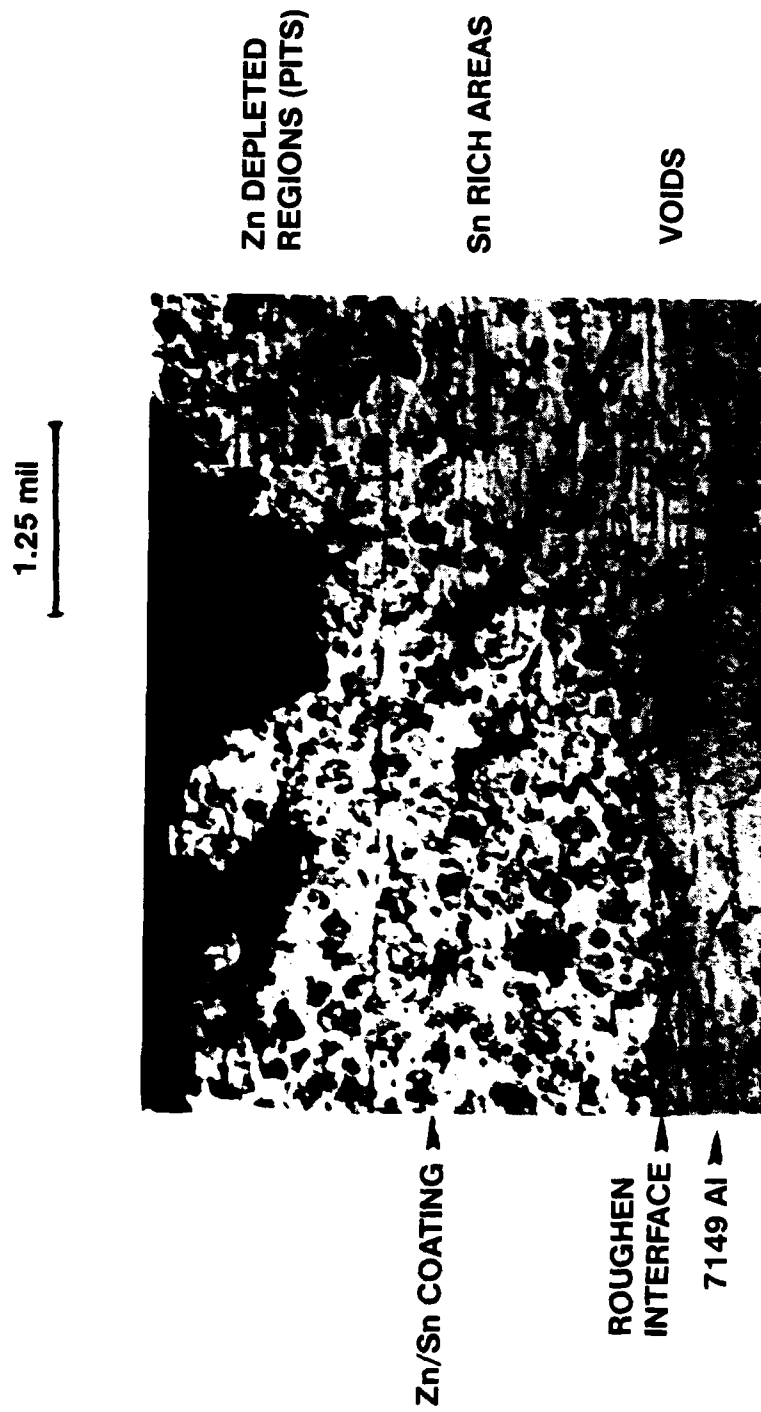
A potential of -0.90 volts was applied to the Zn/Sn coated 7149 panel until the anodic current (dissolution current for Zn) reached zero. At this potential Sn will not corrode as it will be a cathode and Zn will selectively dissolve away leaving the Zn/Sn coating mostly spongy (porous) and rich in Sn. Figure 12 shows a cross sectional view of such a panel after the controlled potential test.

Figure 12 - Cross sectional view of corroded Zn/Sn coating on 7149-T7 Al after controlled potential test.
